Berne Clock Tower

Berne, Indiana

In July, 2010 the town of Berne, Indiana presented the opening of a new landmark, the Muensterberg Plaza and Clock Tower. The 160' tall clock tower, which is a near replica of the original Berne Clock Tower in Berne, Switzerland, provides a time-honoring tribute to the community's Swiss ancestors.

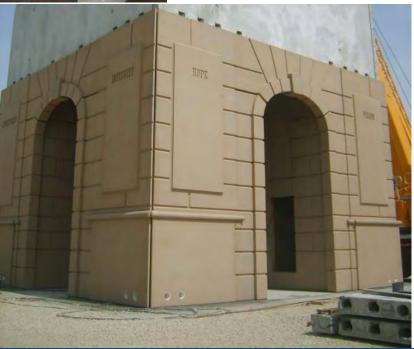
Integral to the success of the construction of the new clock tower was the use of architectural and structural precast concrete to serve as the structural foundation of the tower. The tower consists of a 75' tall precast structure, with a 30' x 30' footprint. There are 3 floors within the 75' tower, each provided as hollow core planks bearing on the exterior precast walls.

The first 20' of the structure is provided with ornate architectural precast concrete panels up to 12" thick, above that the precast panels are provided as 8" thick structural gray, faced with an EIFS system to obtain the final appearance. The tower is topped with an 85' tall prefabricated steel steeple.

The precast producers provided (40) precast wall panels and (37) hollow core planks for the entire structure. Erection was completed in 2 weeks in April, 2010.
